**THE EFFECT OF HYDRAZINE DECOMPOSITION  
PRODUCTS ON THE MECHANICAL PROPERTIES  
OF HIGH-TEMPERATURE ALLOYS**

ROCKETDYNE DIVISION  
ROCKWELL INTERNATIONAL  
6633 CANOGA AVENUE  
CANOGA PARK, CALIFORNIA 91304

TECHNICAL REPORT AFML-TR-77-95  
Final Report for Period 1 March 1976 to 1 April 1977

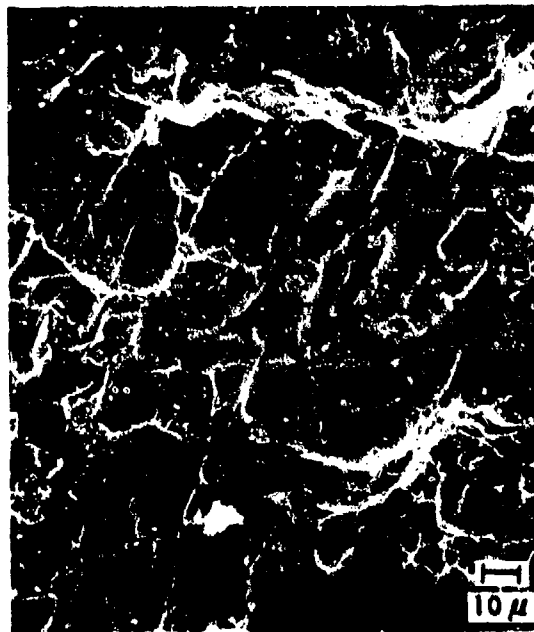
clear for IN-100 as for the other materials, but the fact that there was no significant difference in the fracture appearance between the specimen tested with argon and the specimen tested with  $\text{NH}_3/\text{N}_2/\text{H}_2$ , and the fact that the final shear failure occurred at the inside surface for both specimens, point to a lack of any environmental effect by the  $\text{NH}_3/\text{N}_2/\text{H}_2$  environment. This conclusion agrees with the fact that the low-cycle-fatigue life of IN-100 was essentially the same in  $\text{NH}_3/\text{N}_2/\text{H}_2$  as in argon.
